Unit 3 - Week 1

Week 1

Assignment 1

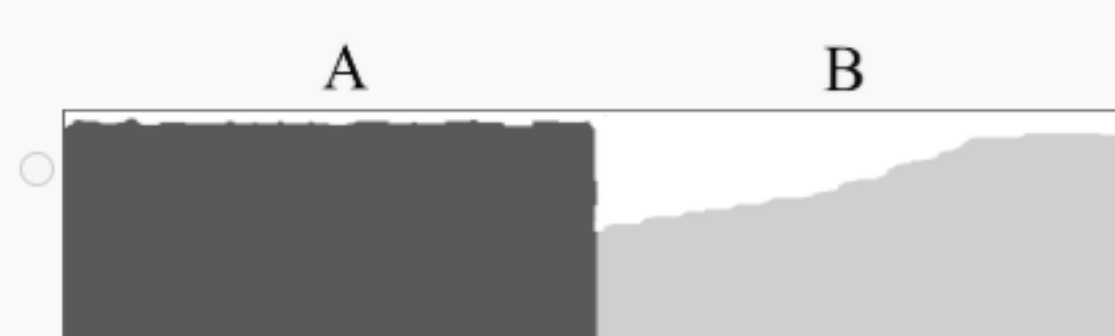
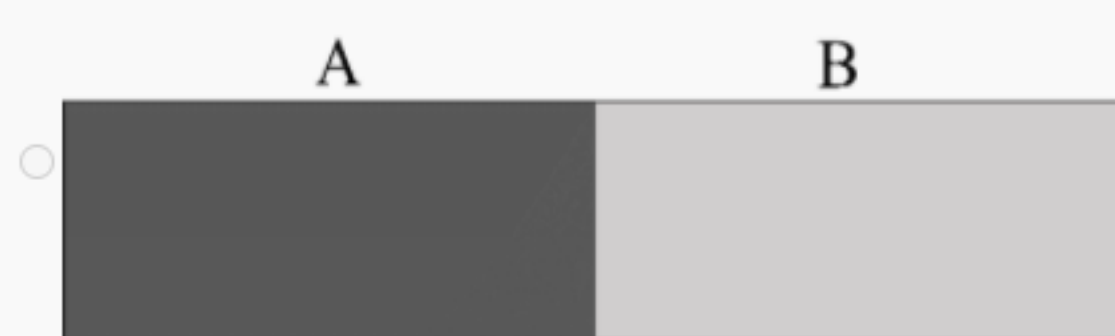
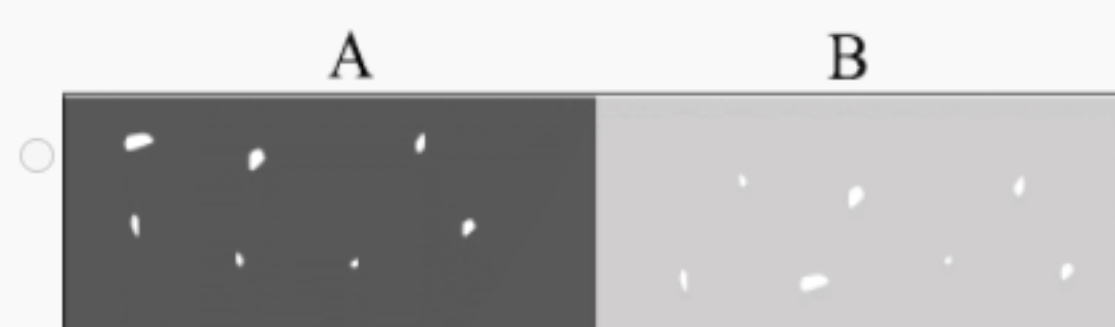
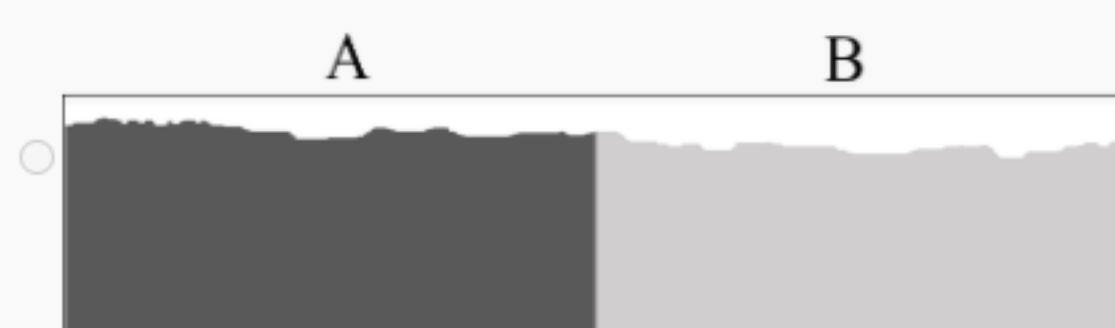
10) Consider that two metals A and B are welded together and exposed to the marine environment. Metal B is more active as compared to metal A. Which of the following schematics correctly illustrates the degradation of the couple? 1 point
